PETRA: WADI AGLAT

Ueli Bellwald

2016 AND 2017 SEASONS 77

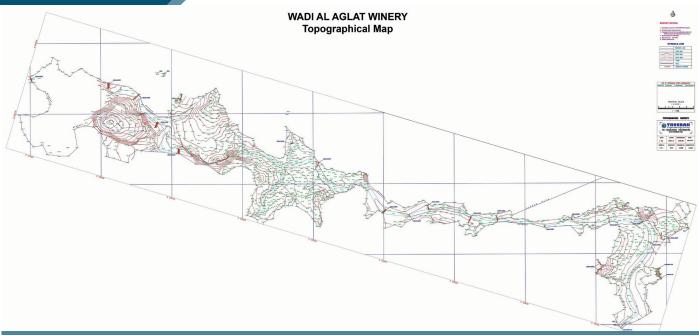
Fig. 70. Topographical map of Wadi Aglat, original scale 1:500 showing the location of all archaeological remains recorded (Drawing by Abdel Atheef Dhibeh). For a high-resolution version of this image, click here.

A detailed archaeological survey in Wadi Aglat, located nearby and to the West of Baydha, was implemented from April to June 2017. The entire area of Wadi Aglat was mapped (Fig. 70) and all visible archaeological remains recorded. The survey revealed the existence of an extensive winery over the full extension of the Wadi Aglat from the western inlet to the eastern outlet and from the northern to the southern cliffs. Before the winery could be set up, the outlet of Wadi Aglat into Wadi Baydha was completely barred by a dam of solid masonry with a height of 4.9 m. The construction of the dam led to the natural deposit of the soil sediments required for the plantation of the vines; hence, Wadi Aglat in its topography became a largely artificial, man-made landscape. Upon the complete accumulation of the sediments, the entire area was terraced for the planting of vines and a sequence of 21 terrace barriers in total was erected to dam up the runoff water to the level of the plantations. The terrace barriers in the upper western part of Wadi Aglat had an original height of around 6 m and led to the accumulation of huge sediments creating an extensive, even area for cultivation (Fig. 71).

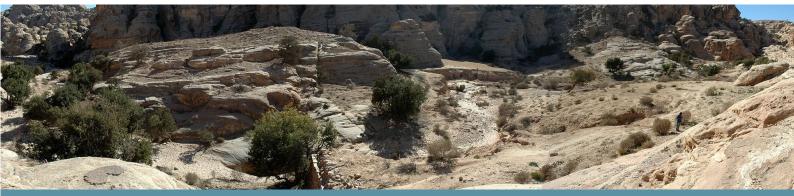
Fig. 71. Panoramic view of the upper, western part of Wadi Aglat from North. At the bottom in the center one of the major terrace barriers with an original height of 6 m may be seen. To the right of the terrace barrier the enormous accumulation of sediments is still visible, despite the erosion having taken place after the earthquake of A.D. 749 (Photo by U. Bellwald).
