Gadara *Intra Muros*

Claudia Bührig
German Archaeological Institute
claudia.buehrig@dainst.de

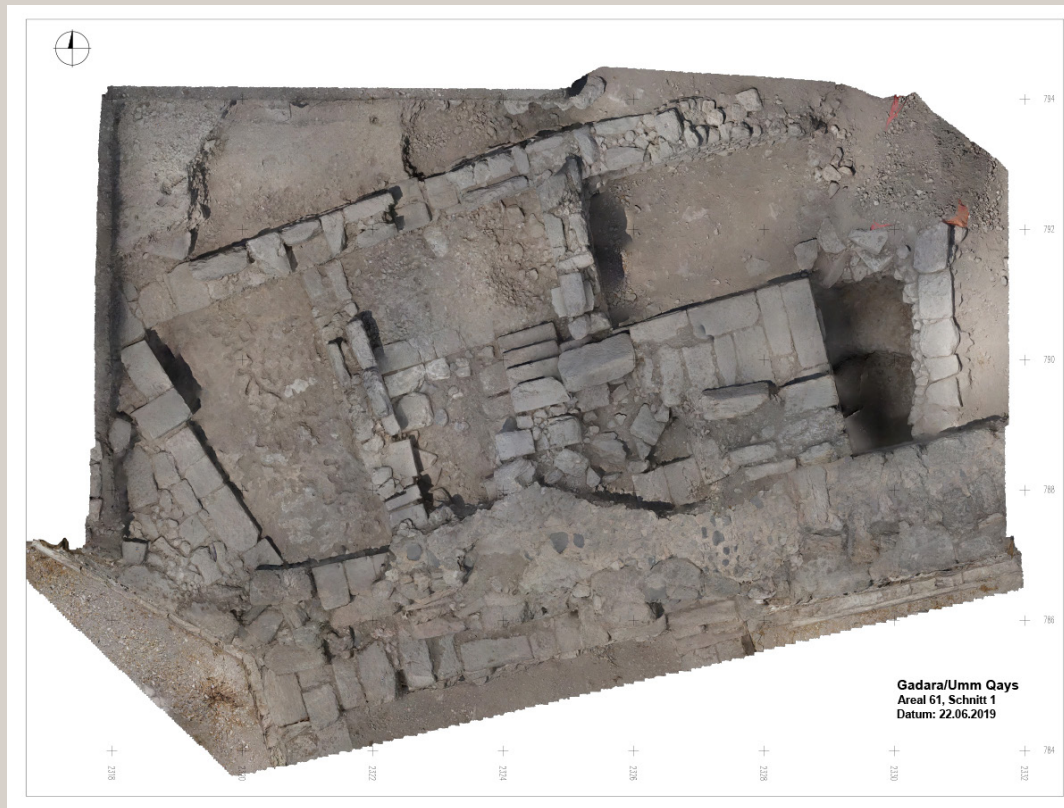
Fig. 1. Gadara/Umm Qays (Jordan). Orthophoto of the construction inside the fortification wall, trench 1. (Photo courtesy of the DAI Orient Department/C. Hartl/Reiter.)

layer (which was unlikely to have been installed before the late Byzantine/early Umayyad period) were found the remains of a building with at least two stories that is suspected to belong to the early Roman period. This was constructed on the inside of the fortress wall, using a massively layered platform and the addition of a gate. The building was connected by an alleyway to the north, which ran parallel to the wall (Fig. 1). The exact construction sequence can be determined only by further excavations.

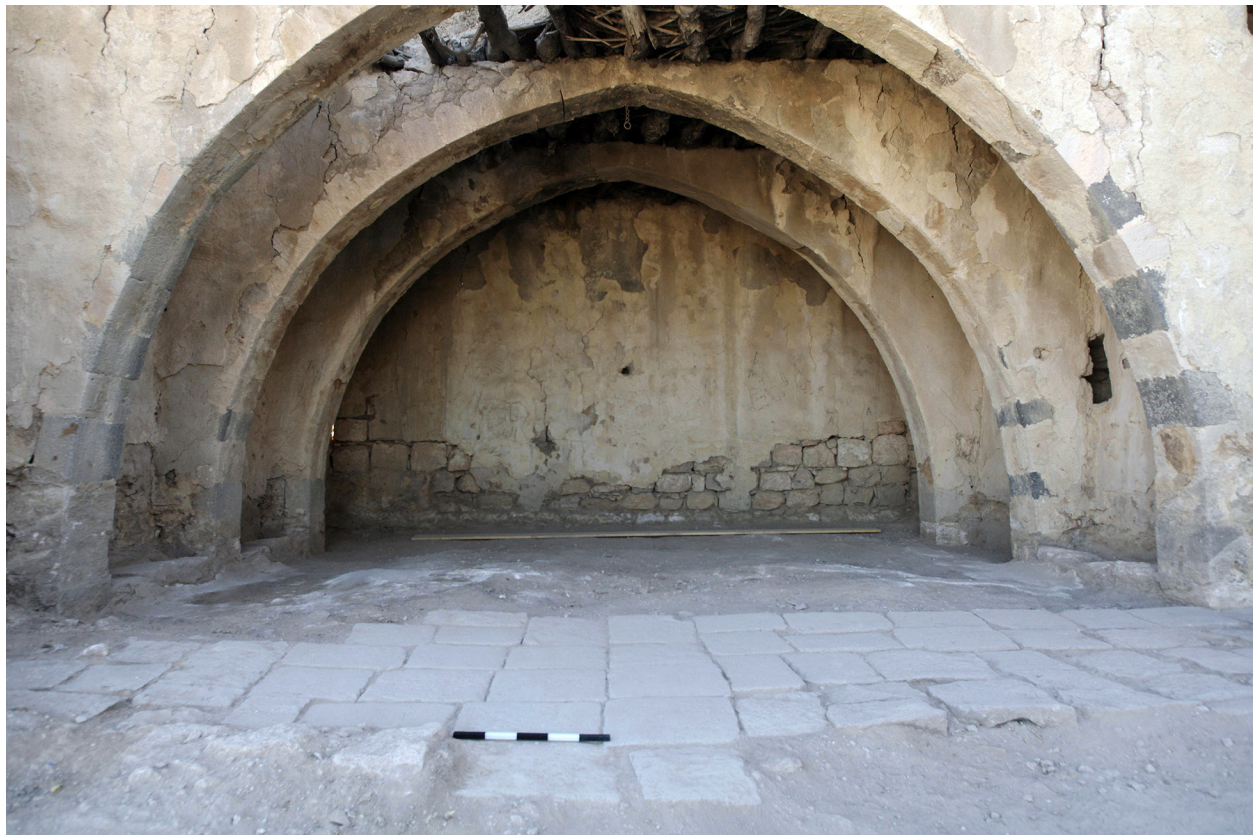
Fig. 2. *Madafeh* (living room) from the end of the 19th century in the old town of Umm Qays/Hara Foqa (Jordan). (Photo courtesy of the DAI Orient Department/C. Bührig.)

Another initiative in the old village of Umm Qays (Hara Foqa) on the hilltop concerns house construction and building techniques of the late 19th and early 20th centuries. These structures are unique in their state of preservation and are largely unknown. Large courtyard houses belonging to the landowner—arranged at almost right angles and all with flat roofs and square rooms, grouped around large, undeveloped inner courtyards—as well as small-scale farmsteads forming a loose grouping of individual buildings, characterize the townscape. Typologically, the courtyard-house complexes orient themselves more towards the Palestinian-Arabian house construction of the region. The documentation of selected courtyard houses and special buildings and their urban integration and cultural value was continued in 2018/2019. Whereas local stones such as basalt and limestone were uniformly used as construction material for the masonry (mostly repurposed ancient construction material), the preserved roof constructions, in contrast, display technical diversity (Fig. 2). In a region lacking in long timber, other options for covering wide spans needed to be pursued. Some individual buildings, namely those from the first construction phase in the late 19th century, still show adjusted relief arches, upon which rested crooked beams of tamarind wood. Things changed for the buildings built during the early 20th century; adjusted arches are either missing here or continue their original function as support. Repurposed railway tracks span the entire interior. Not all buildings in the courtyard house complex could be assigned a function yet, and the destruction is so severe in some places that the design of individual components—e.g., façades—first had to be cleared by ongoing photo research.
