Amman Roman Baths Rescue Excavations

Asem Asfour
Department of Antiquities
asemasfour@hotmail.com

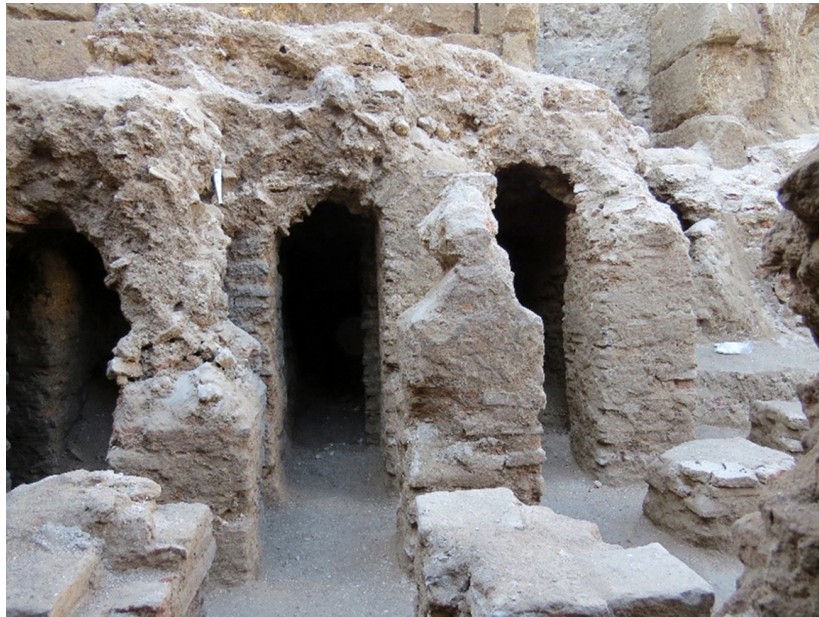
Fig. 1. The burning chambers, part of the hypocaust system. (Photo by Asem Asfour.)

Excavations began on September 12, 2020, and ended on January 15, 2021. The excavation was carried out by the Amman Antiquities Directorate, and the initial results revealed the remains of burning chambers (boilers), which were built of bricks/refractory bricks. These chambers were used to heat water and represent the lower part of a Roman public bath, consisting of a group of burning chambers with a length of 20 m and a width of 11 m (Fig. 1). There are thirteen of these chambers on the northern façade, twelve in the southern façade, and eight on the western façade, while the those on the eastern side were too damaged by

bulldozing to properly interpret. The burning chambers are about 1.75 m in height, and their widths range between 43 cm and 55 cm. Excavations also revealed the ignition chamber and the main burner of the bath room (with a length of 6.35 m, a width of 55 cm and a height of 1.45 m), in addition to the gates that were used to supply these burning chambers with the materials needed for ignition and burning and to remove the remains of the fuel.

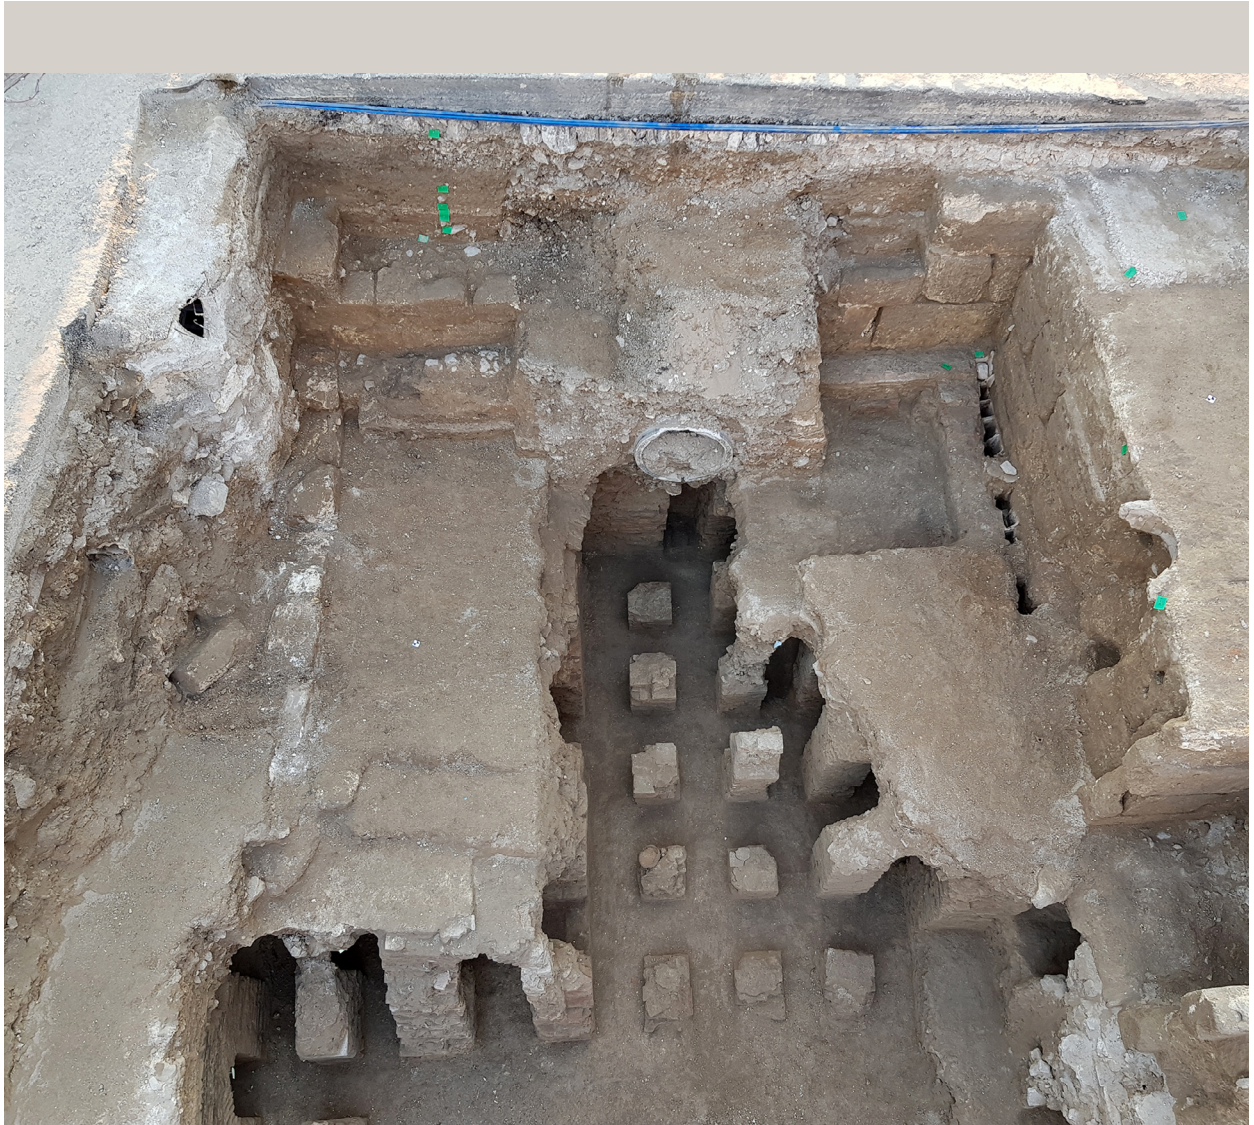
Fig. 2. Top plan view of the Roman bath. (Photo by Asem Asfour.)

The work also revealed rectangular pottery pipes sticking to the walls of the bath room from the inside; these pipes worked as a smoke evacuation system and supplied the burning rooms with oxygen. The excavations revealed some internal walls related to the rooms of the Roman bath; the height of the walls from the floor of the furnace to the level of the modern asphalt street was 4 m (Fig. 2).
